Manhole Inspection Summary

Manhole # S17YY_011MH

Insp Date: **3/2/07 12:54 PM**

Location Address: **3467 COTTAGE AVE**

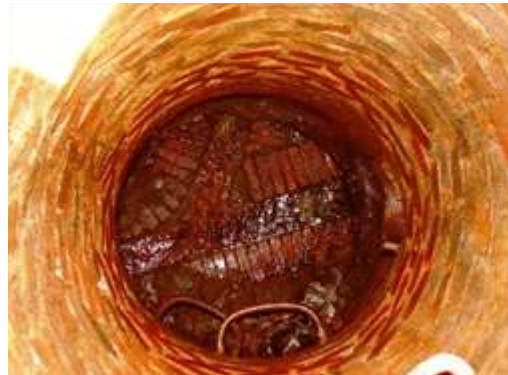
Top View

Bench debris. Corroded steps.

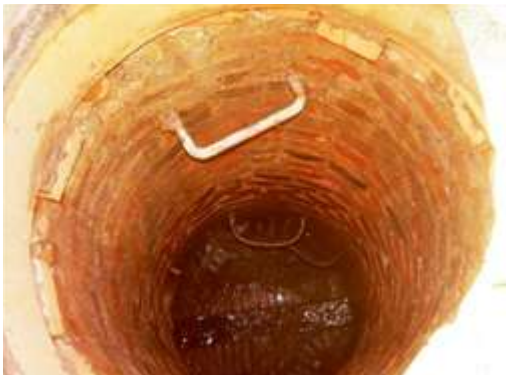
Defect

Frame leaks. Adjustment deterioration, loose brick and infiltration.

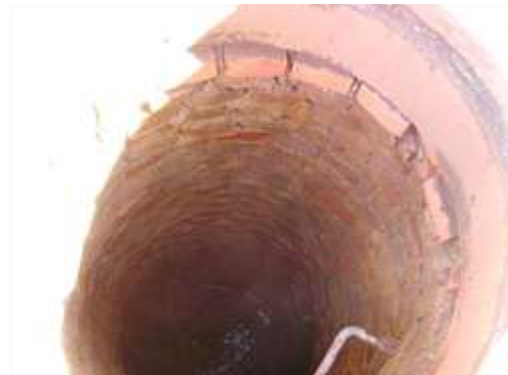
Defect

Frame leaks. Adjustment loose brick, deterioration and infiltration.

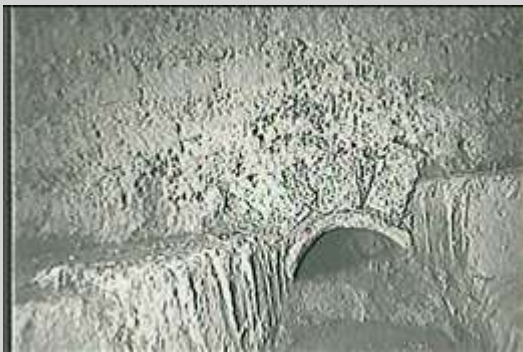
8 in. Circular Gravity Sewer Pipe Out @ 12 O'Clock

Deposits: ☐ None ☒ **Mud** ☐ Sludge ☒ **Debris** ☐ Grease

Silt Depth: **4** (in.) Deposits Extent: **Medium**

Infiltration: **None** Pipe Seal Cond: **Cracked**

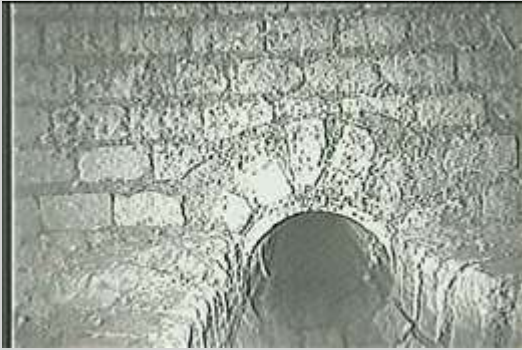
8 in. Circular Gravity Sewer

Channel deterioration.
